**Industry:** Plating

**Application:** Part Washing

**Product Descriptions:** 1/4" NF10-90

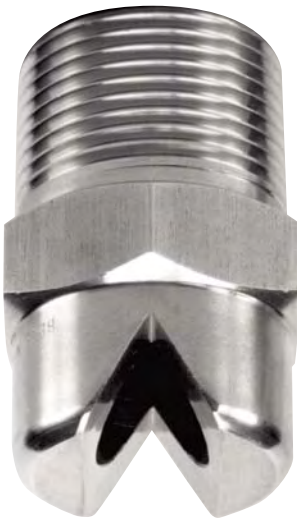
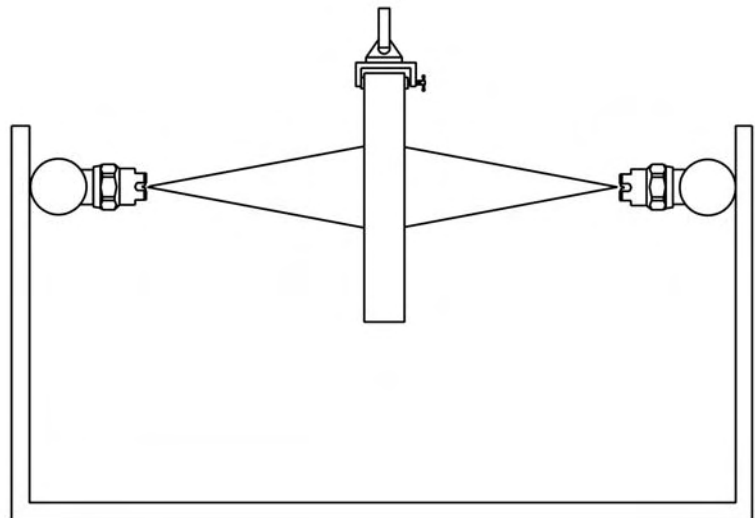
**BETE's solution:** BETE Application Engineers recommended the standing fluid be replaced with two headers with NF fan nozzles mounted on them. The headers created a horizontal water wall much like the surface of the standing fluid. As the parts were lowered through this water wall they would be rinsed. The cross-contamination from different processes is eliminated because there is no longer any standing fluid.

**Situation:** A plating company was having trouble with cross-over contamination in their rinsing bath since they use the same rinsing/washing bath for several different plating processes. The current rinsing bath is a large rectangular tub with standing fluid that the parts are lowered into.
